Smoke and Dye Testing Summary

High Level Sewershed

Test ID	Test Type	Date Inspected	Company / Super.	Nearest MH	Ground Condition	Notification Made?		
D1028-160	Dye	4/23/2009	ADS/TM	S09YY_014MH	Damp	NA		
Address	3607 Cedardale Road		Location	Curb	Status	Public	Source	Catch Basin

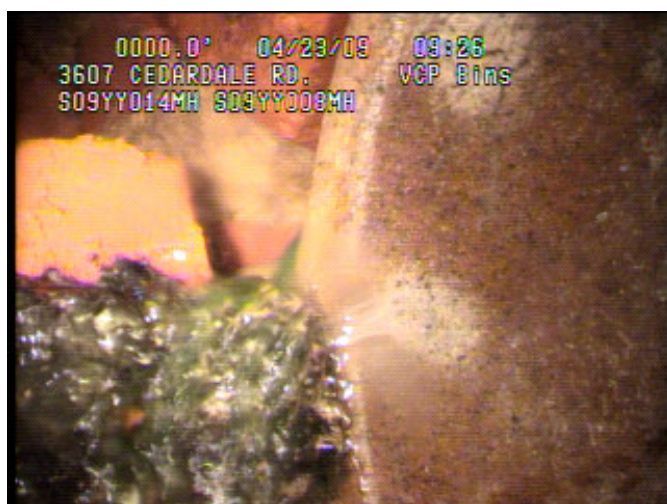
Picture \D1028-160-OB01-P01.jpg

Comments Dye observed at connection between S09YY_014MH and S09YY_008G2. Infiltration gusher at 9 oclock.

Comments Connection between S09YY_014MH and S09YY_008G2.

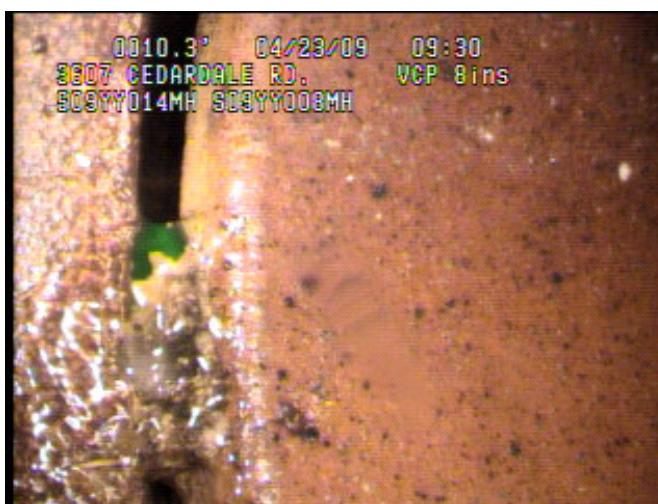
Picture \D1028-160-OB02-P01.jpg

Comments Dye observed 10.3 ft. upstream of S09YY_014MH. Infiltration runner at joint at 9 oclock.

Comments 10.3 ft. upstream of S09YY_014MH along S09YY_008G2.

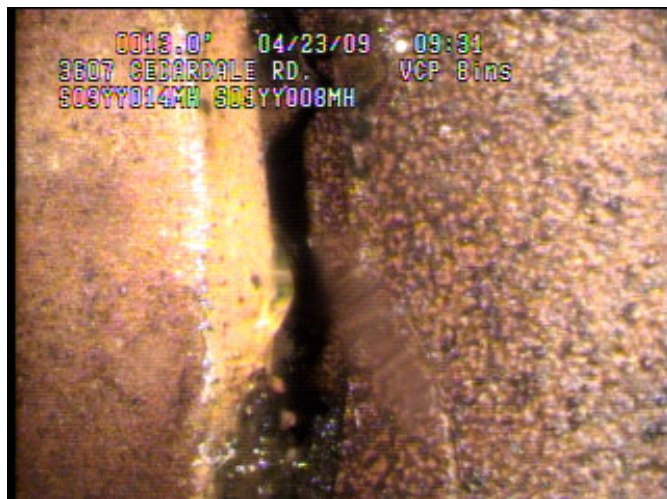
Picture \D1028-160-OB03-P01.jpg

Comments Dye observed 13.0 ft. upstream of S09YY_014MH. Infiltration runner at joint at 2 o'clock.

Comments 13.0 ft. upstream of S09YY_014MH along S09YY_008G2.

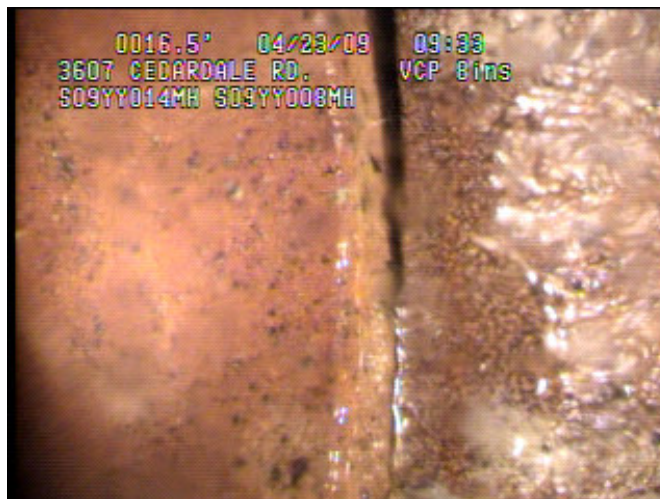
Picture \D1028-160-OB04-P01.jpg

Comments Dye observed 16.5 ft. upstream of S09YY_014MH. Infiltration runner at joint from 12 to 2 o'clock.

Comments 16.5 ft. upstream of S09YY_014MH along S09YY_008G2.
